## ELASTIC PITCH BEAM TAIL ROTOR

Kaman Aerospace Corporation  
Bloomfield, Conn. 06002

December 1976

Final Report for Period August 1971 - April 1976

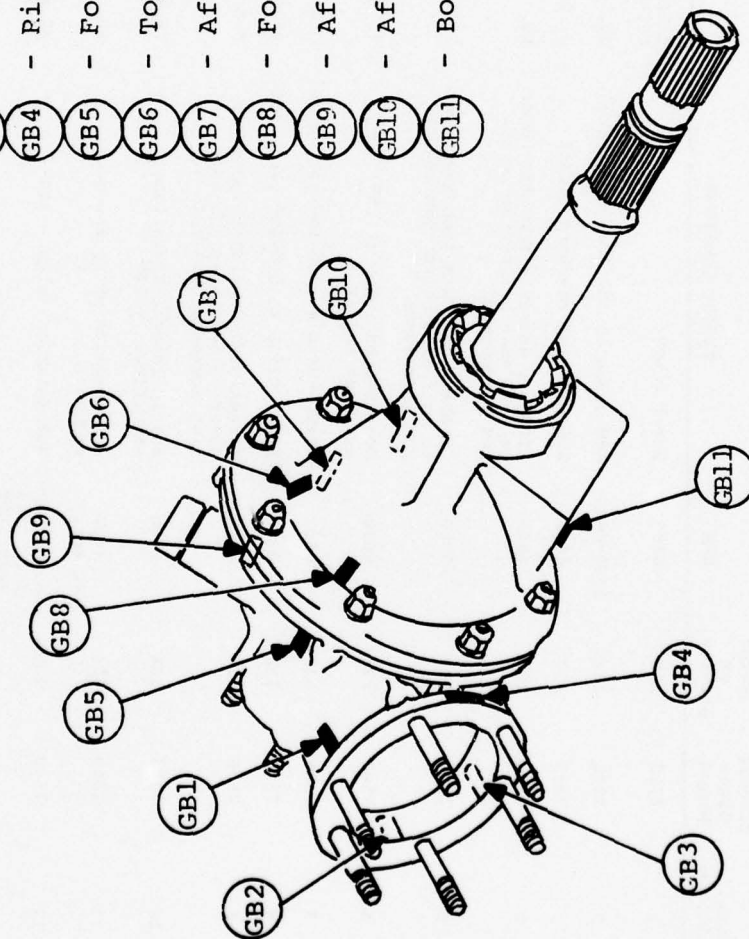
Figure 48. 90° tail rotor gearbox strain gage locations.

Figure 56 shows the variation of the tail rotor 90° gearbox vibratory strain levels with airspeed for both the EPBTR and the standard tail rotor installation. The three locations shown here are the areas that produce the highest strain levels. Strains on the left side mounting area (GB2 Figure 48) with the EPBTR installed were the highest recorded closely approaching the endurance limit of  $\pm 277$  micro inches/inch. This condition occurred during the high-speed level-flight condition and also during a 40-degree left banked turn at 70 knots. The strain levels are higher than those measured with the standard tail rotor installed due to the increase in shaft bending moments associated with the nonteetering EPBTR. Gage locations GB2 and GB3 are the only areas that showed differences in strain levels between the two tail rotor configurations. No fatigue damage was accumulated by the tail rotor gearbox during these flights, as the resulting strains did not exceed their endurance limit.

Data recorded during these flights indicated that the resultant vibratory bending moments acting on the tail rotor shaft were below the 3150 inch-pound endurance limit previously established for this component. The highest strains recorded on the tail rotor gearbox were at strain gage Number GB2, Figure 48, and the highest strains recorded on the tail pylon were at strain gage Number 5L, Figure 71.

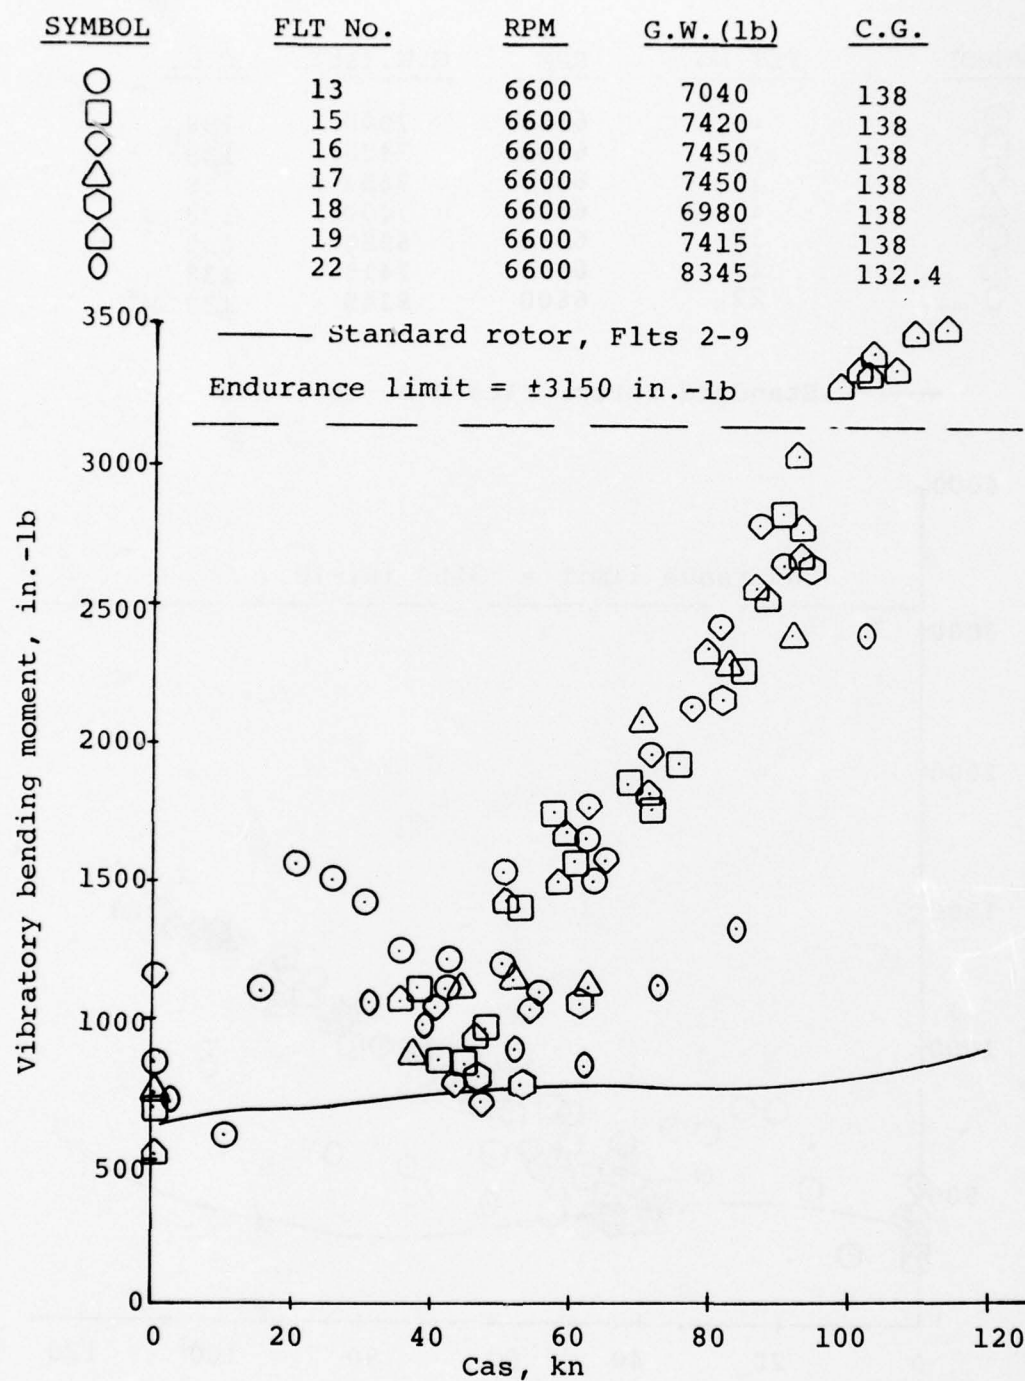
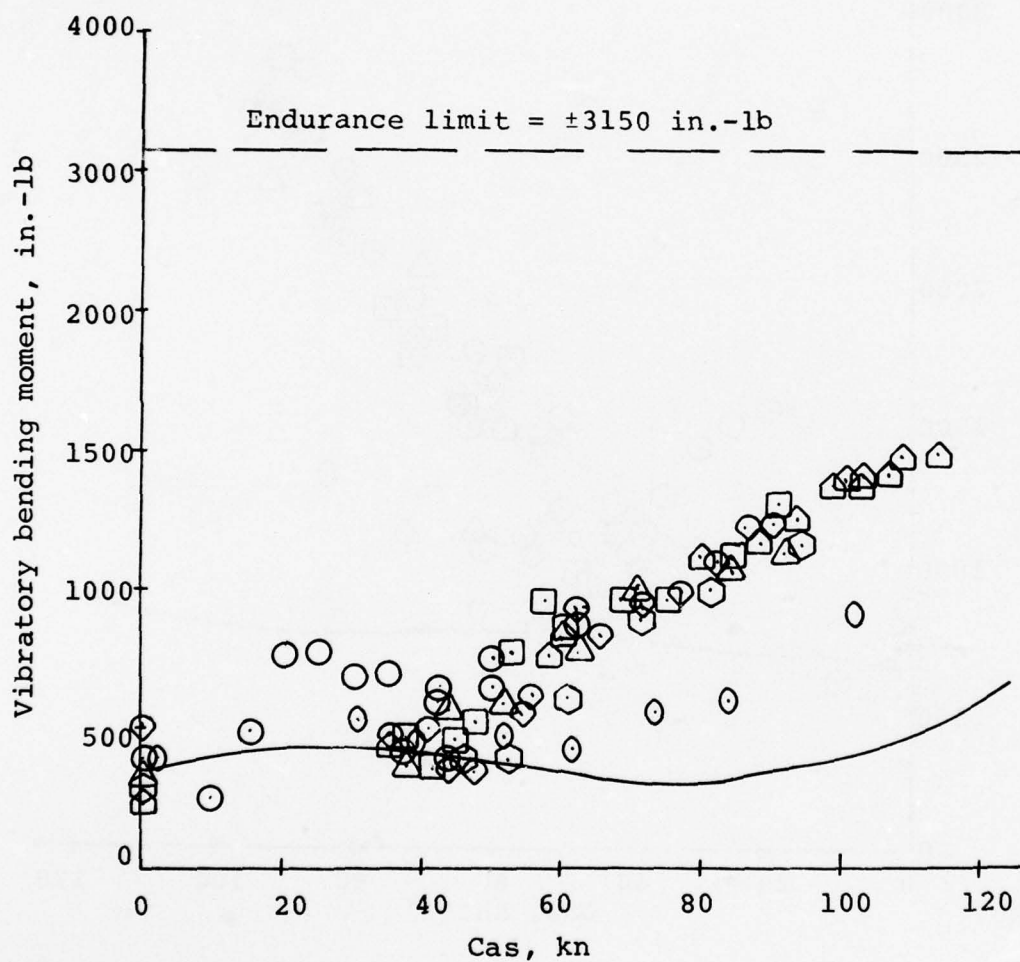
Figure 50. Vibratory tail rotor shaft bending moment versus airspeed.

rotor shaft was calculated to be approximately 4% by using Miner's Cumulative Damage Criteria:  $D = \sum n/N \times 100$ , where D is the percent of cumulative damage, n is the actual number of cycles at a specific load level, and N is the allowable number of cycles at the specific load level. It was determined from the flight data of Figure 50 and the cumulative damage analysis that the nonteetering EPBTR could be flown up to 90 knots without the resultant vibratory shaft bending moments exceeding the 3150 inch-pound endurance limit - the airspeed restriction previously predicted by analysis. Therefore, all subsequent level flights made with the nonteetering EPBTR installed were restricted to 90 knots to prevent the accumulation of additional fatigue damage. It is also noted in Figure 50 that at the higher gross weights and more forward center of gravity locations, the vibratory shaft bending moments are significantly reduced.

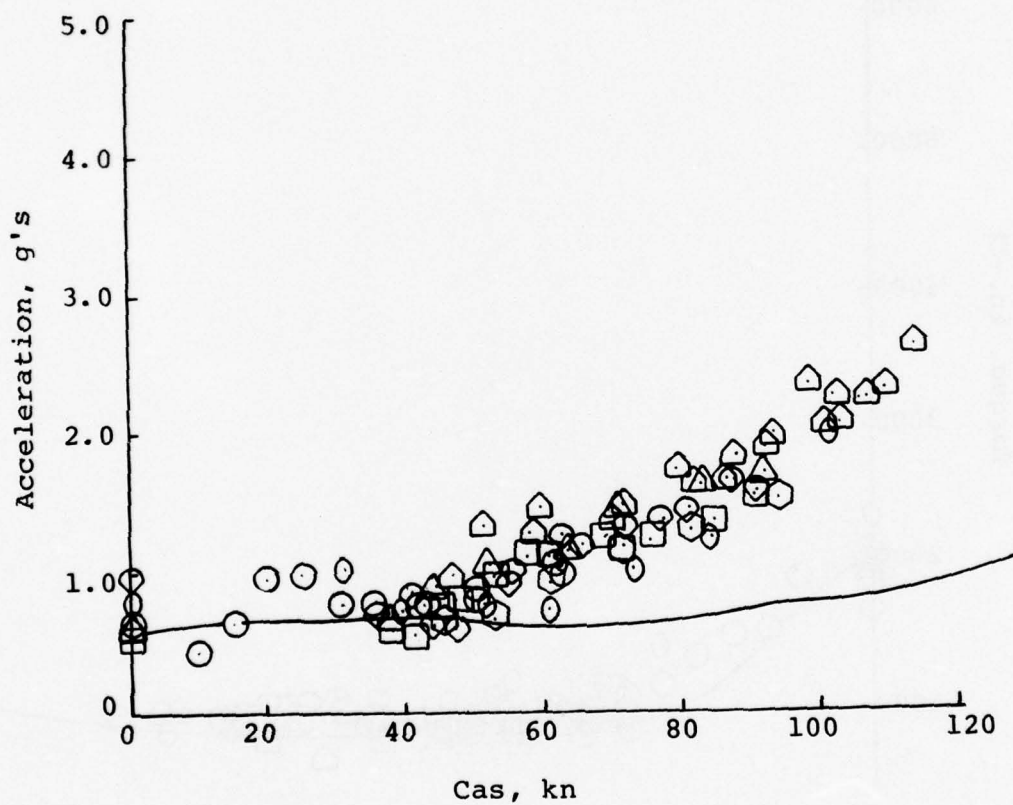
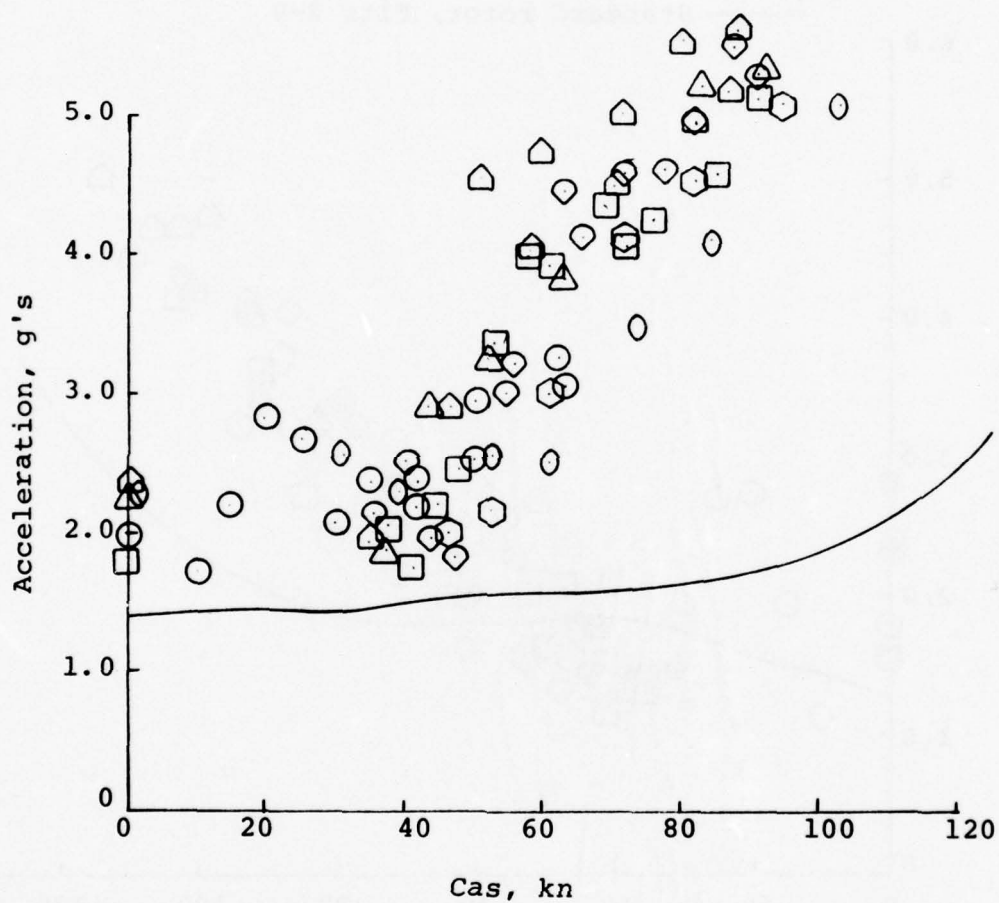
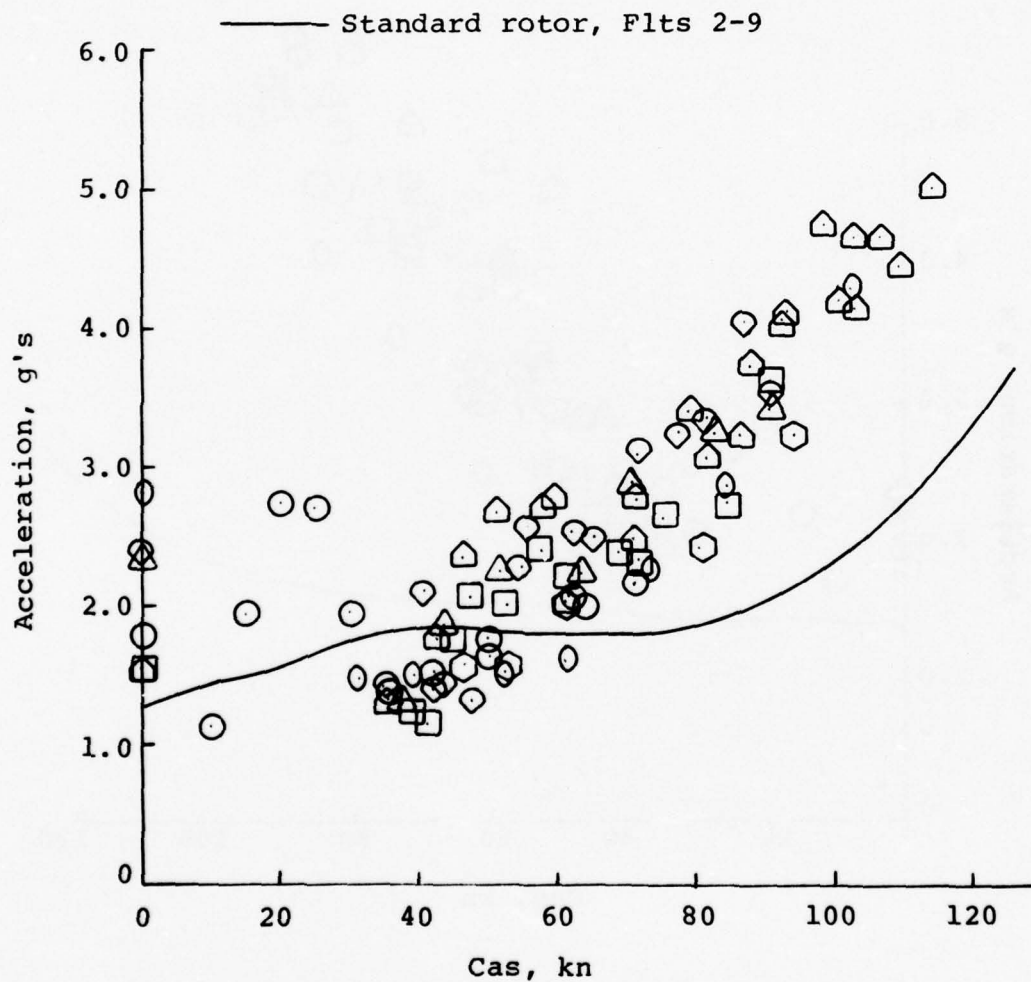
Figure 55. Tail pylon accelerations versus airspeed.

Figure 55 presents the vertical, longitudinal, and lateral accelerations experienced by the upper tail pylon during the airspeed sweeps. Accelerations in all three directions were much higher with the EPBTR installed than with the standard tail rotor installed. The predominate frequencies associated with these tail pylon accelerations and the EPBTR are 2/rev and 4/rev of the tail rotor. This increase in tail pylon accelerations can be attributed to the increase in tail rotor shaft bending moments due to locking out the teeter freedom of the EPBTR. A direct assessment of the fatigue damage that may have occurred during flight at the higher airspeeds could not be made as tail pylon strain gages were not installed during the

Engineering-Flight Test Program. An estimate of the possible amount of damage that could have occurred can be obtained by noting that the relative relationship of the maximum strains to their respective endurance limits for the tail rotor gearbox and tail pylon, obtained during subsequent R&M flights, were approximately the same, and that during the Engineering Flight Test Program, the tail rotor shaft was found to be more critical than the tail rotor gearbox. It can then be concluded that the fatigue damage incurred by the tail pylon could be no greater than 4%.

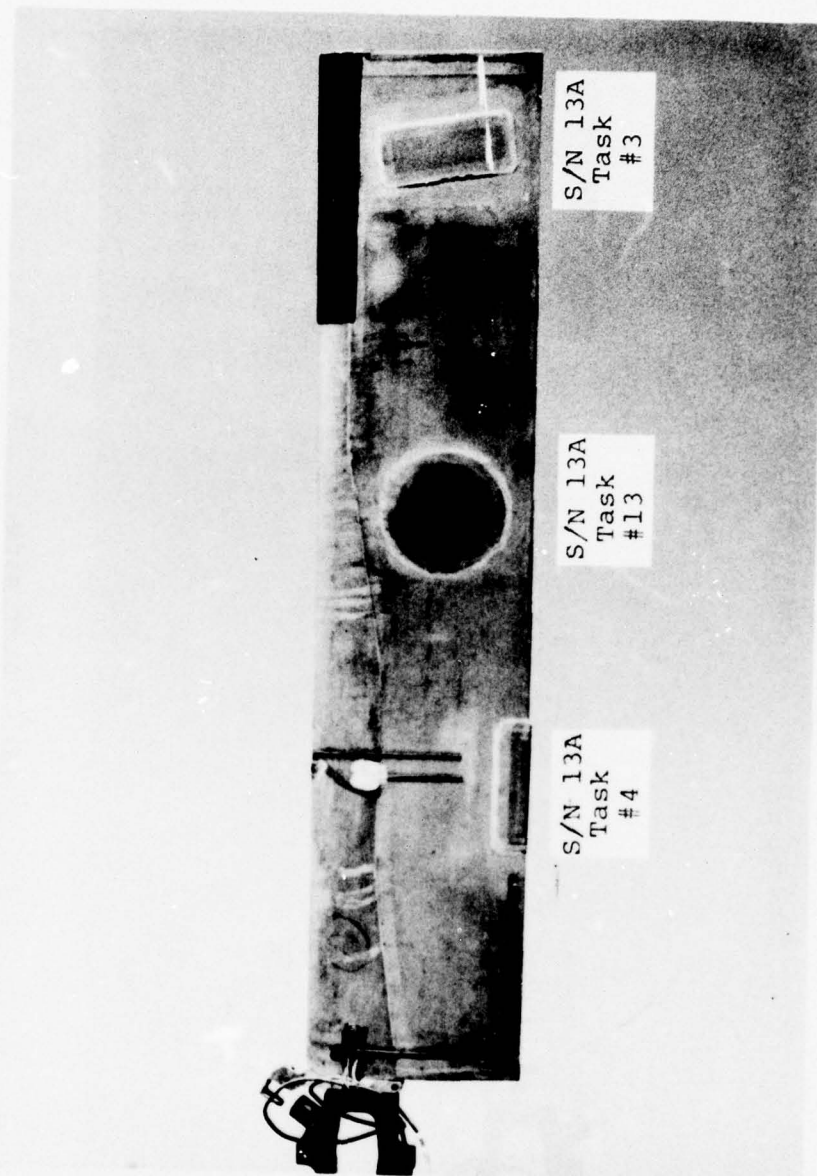
Figure 62. Repaired elastic pitch beam tail rotor S/N 13A.

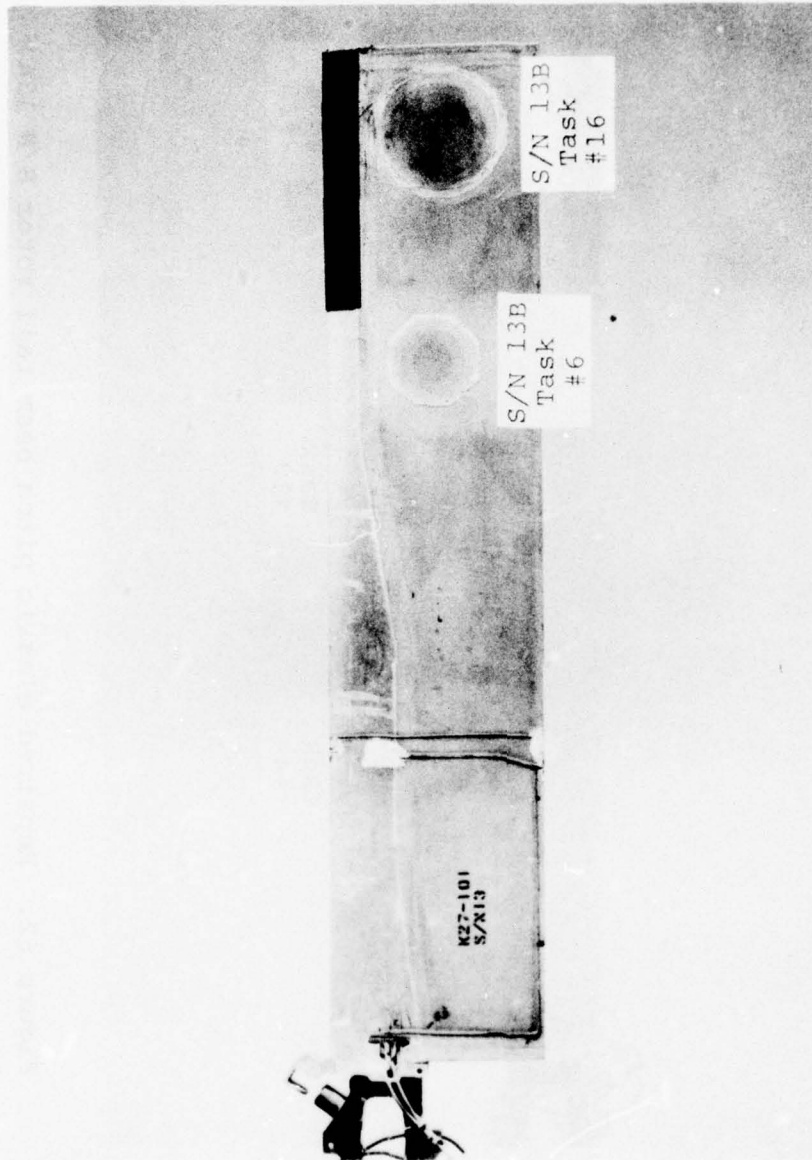
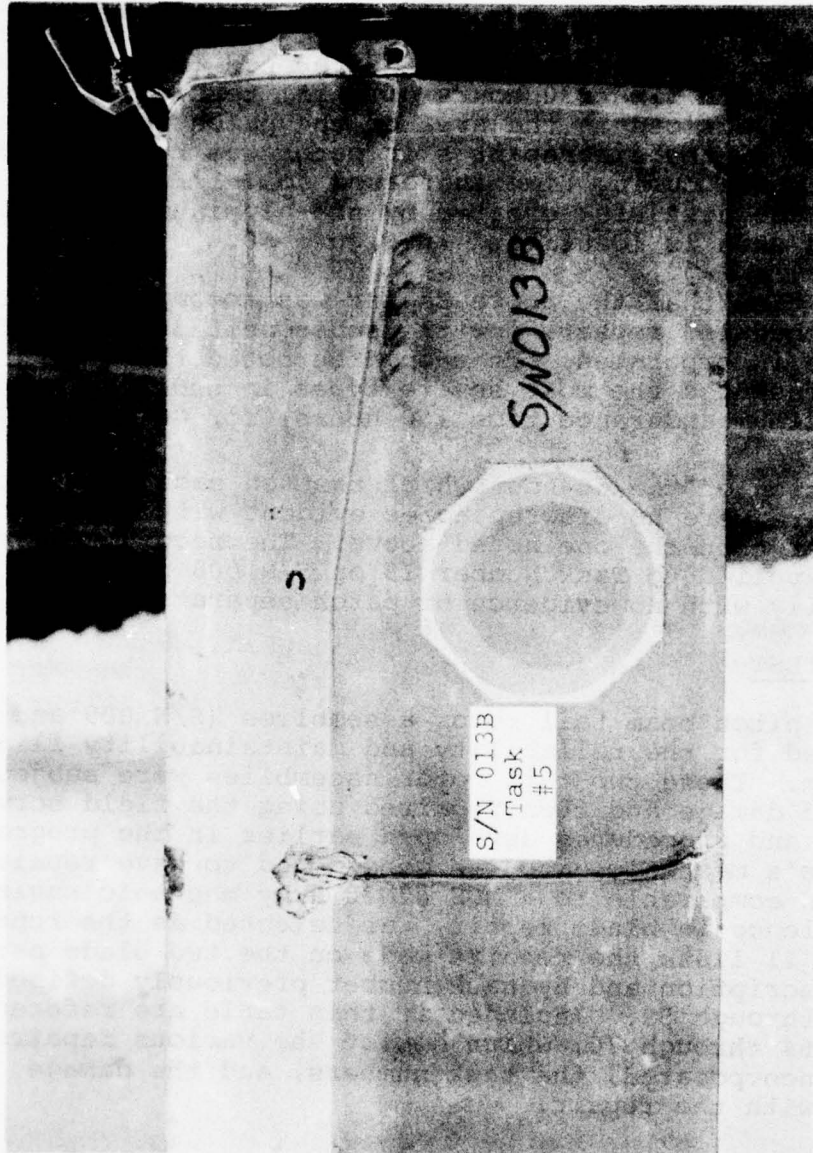
Figure 63. Repaired elastic pitch beam tail rotor S/N 13B.

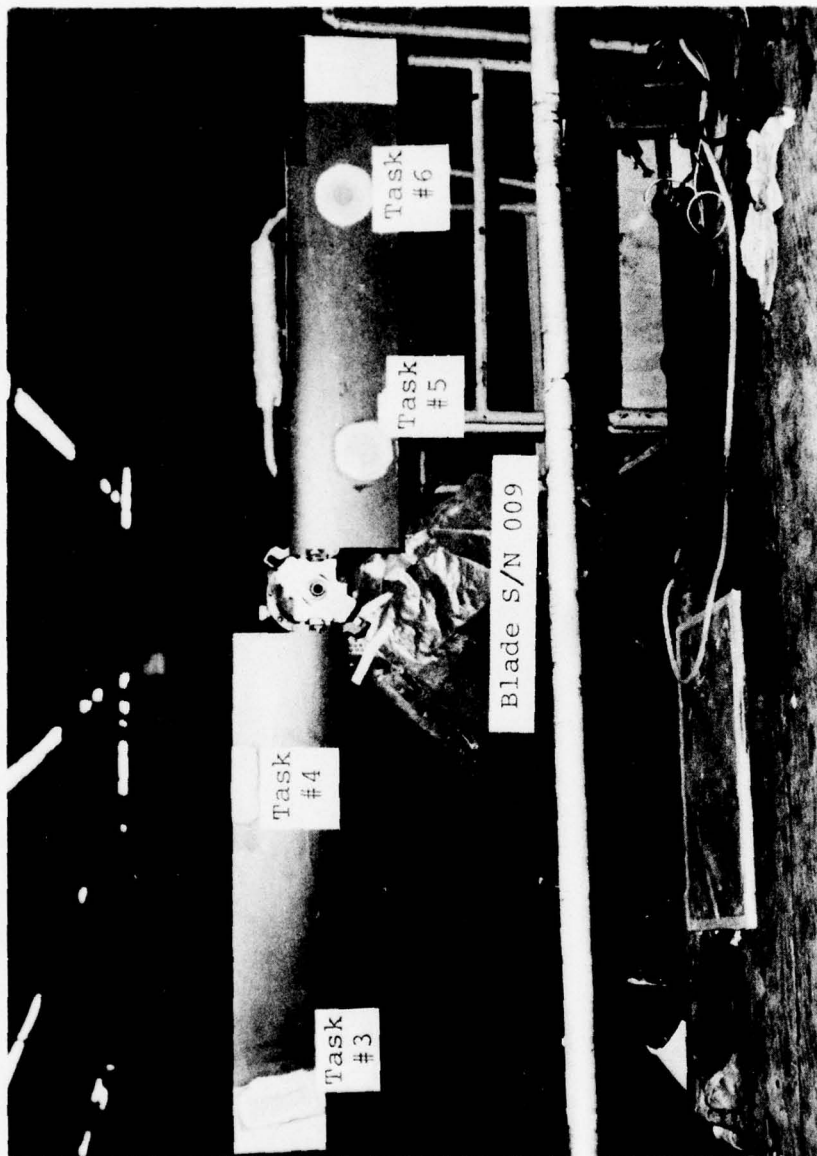
Figure 64. Repaired flight blade specimen (prior to 5 hr whirl).

Blade S/N	Type of Repair	Task No.	Hours Tested	Repair Location		Figure
				Station	Chordwise	
009A	2-1/2-in. x 6-in. Skin Patch	3	20	46.69	5.7	64 repaired
009A	6-in. Long Vee Patch	4	20	17.49	10.0	64 repaired
009B	4-in.-dia Skin Patch	5	20	12.69	6.8	64 repaired
009B	2-in.-dia Plug/Patch	6	20	36.29	5.0	64 repaired
012A	3-1/2-in.-dia Through Plug/Patch	13	20	30.29	5.1	65 damaged 66 repaired
012A	2-in.-dia Plug/Patch	15	20	45.29	4.6	67 damaged 68 repaired
012B	5-in.-dia Skin Patch	14	20	37.89	5.5	69 damaged 70 repaired
012B	3-1/2-in.-dia Plug/Patch	16	20	46.79	5.2	69 damaged 70 repaired

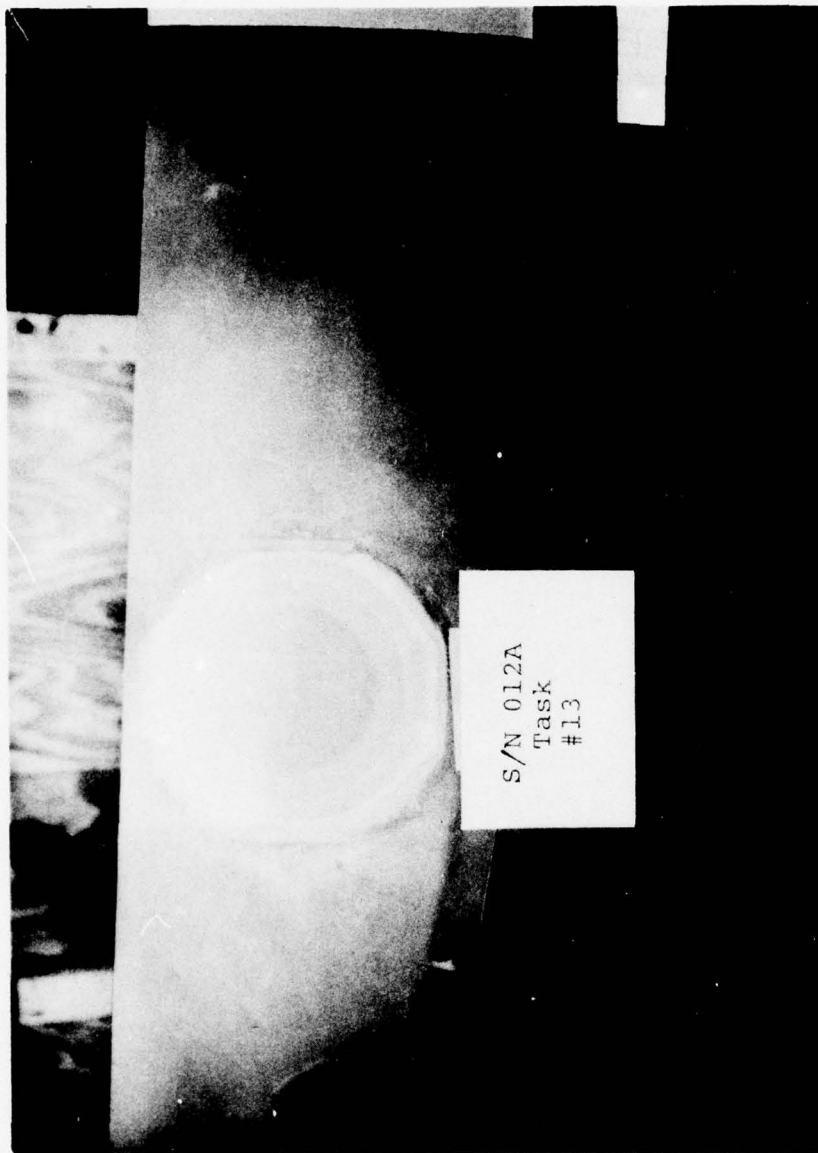
Figure 66. Repaired flight blade specimen.

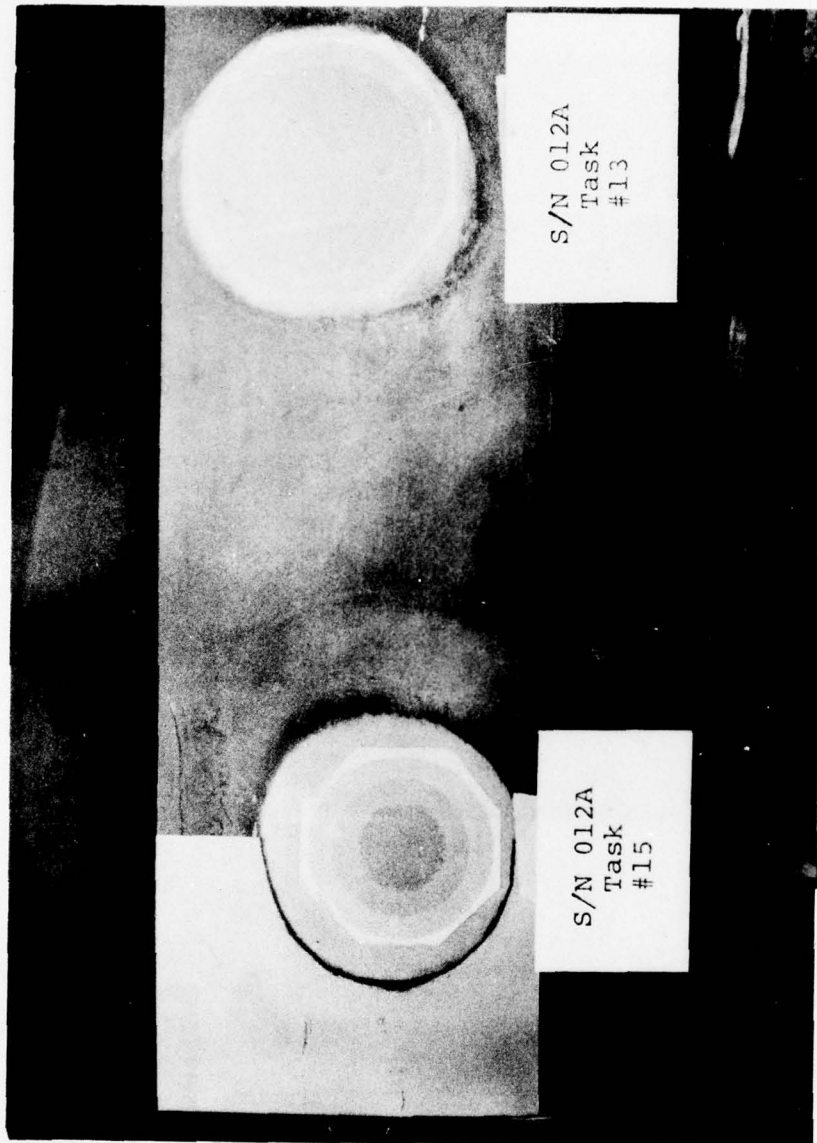
Figure 68. Repaired flight blade specimen.

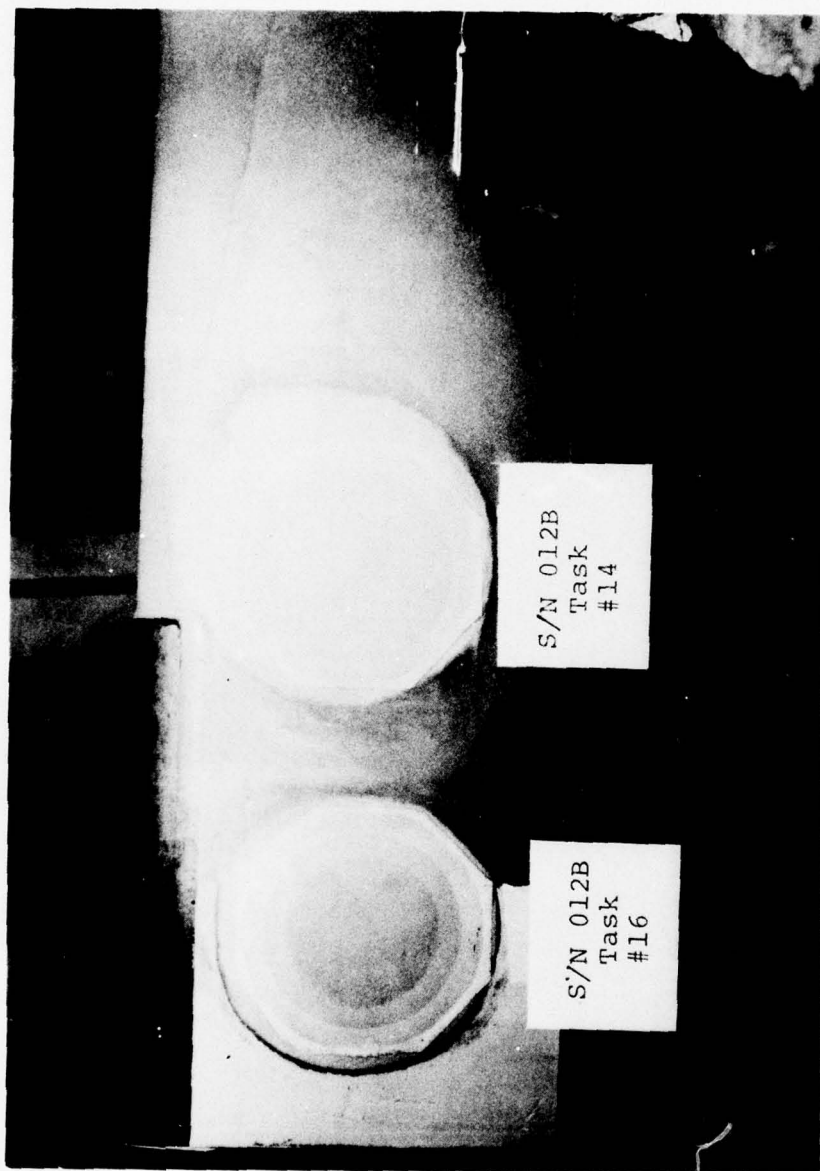
Figure 70. Repaired flight blade specimen.

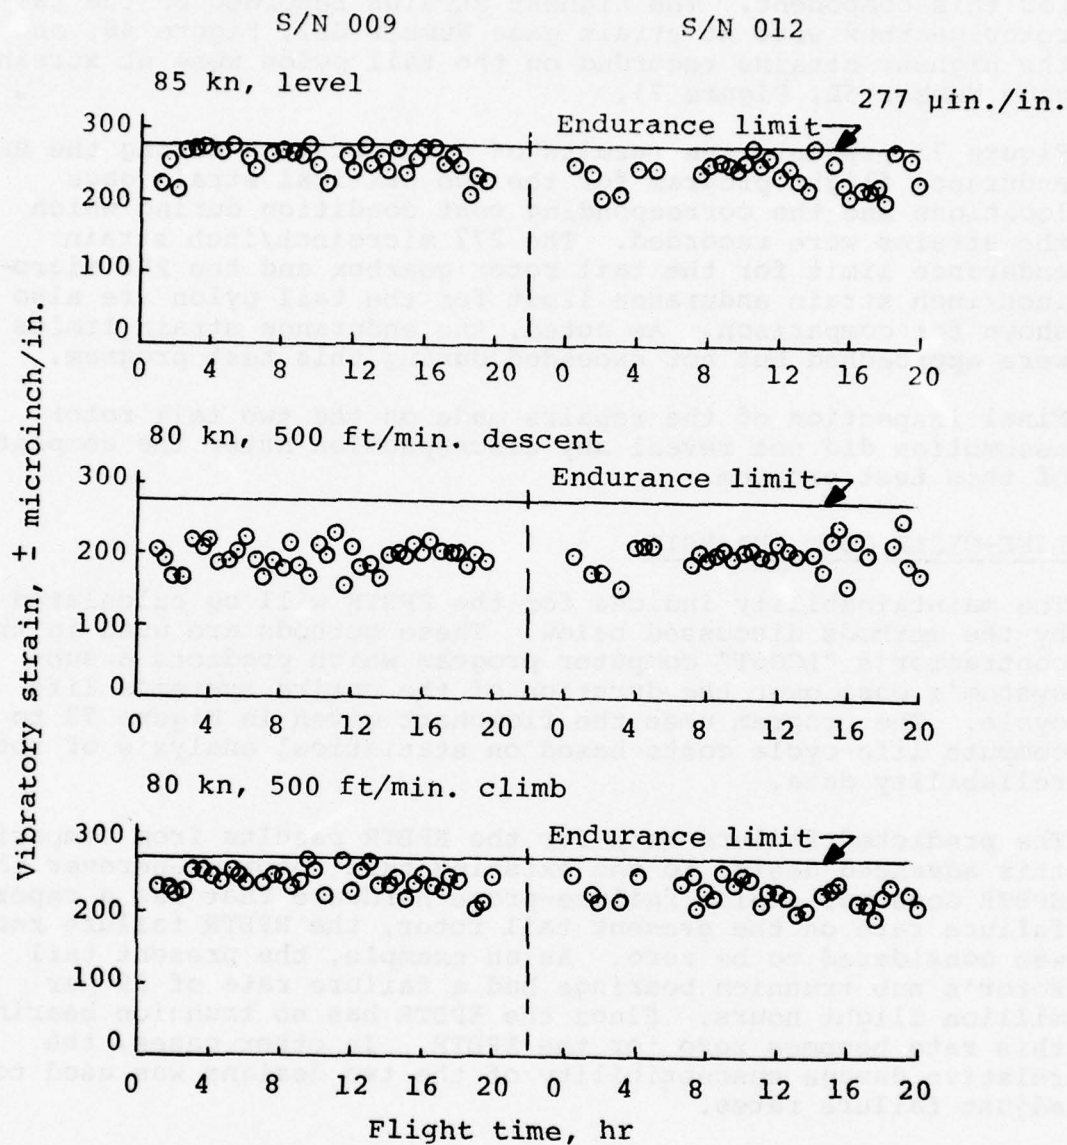
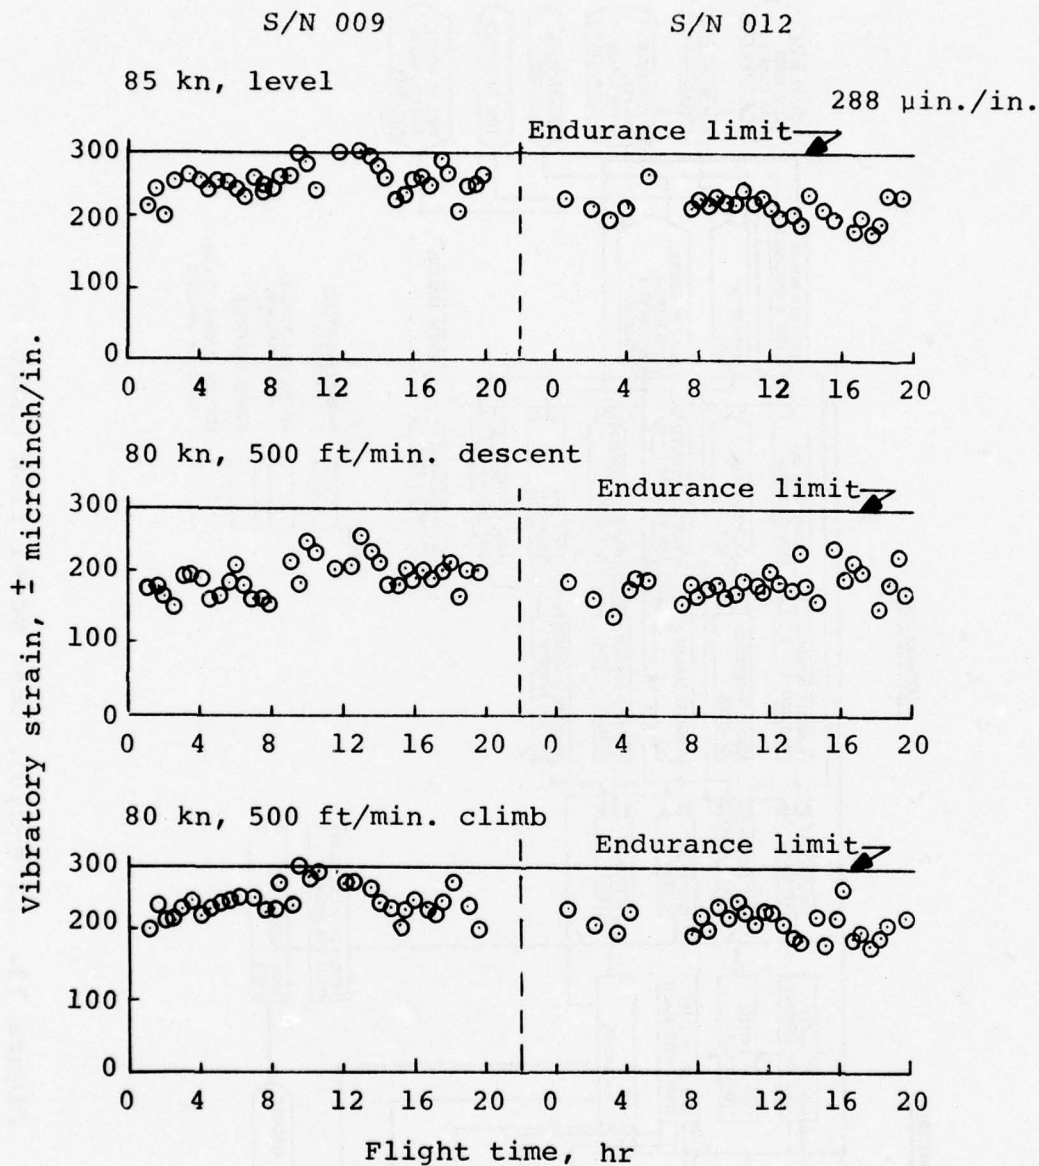
Figure 72. Vibratory strain versus flight time for the tail rotor gearbox and tail pylon.

Figure 72 presents the results of data obtained during the R&M endurance flight program for the two critical strain gage locations and the corresponding test condition during which the strains were recorded. The 277 microinch/inch strain endurance limit for the tail rotor gearbox and the 288 microinch/inch strain endurance limit for the tail pylon are also shown for comparison. As noted, the endurance strain limits were approached but not exceeded during this test program.
